**SEISMIC AND GEOELECTRIC TOMOGRAPHY RESULTS IN CONCRETE AND
ROCKFILL DAMS IN ALBANIA**

A. Frasheri*, F. Dhima**, P. Nishani*, L. Kapllani*, E. Xinxo*, B. Çanga*

Abstract

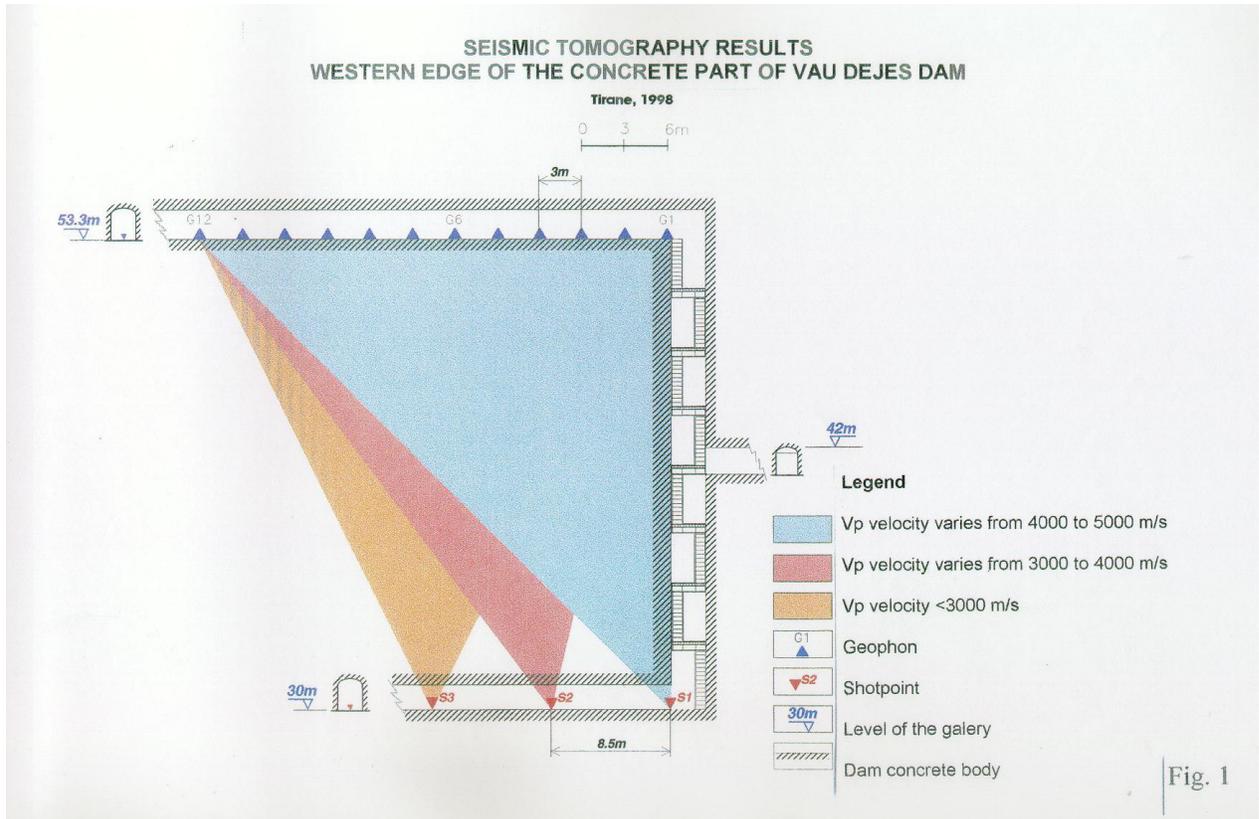
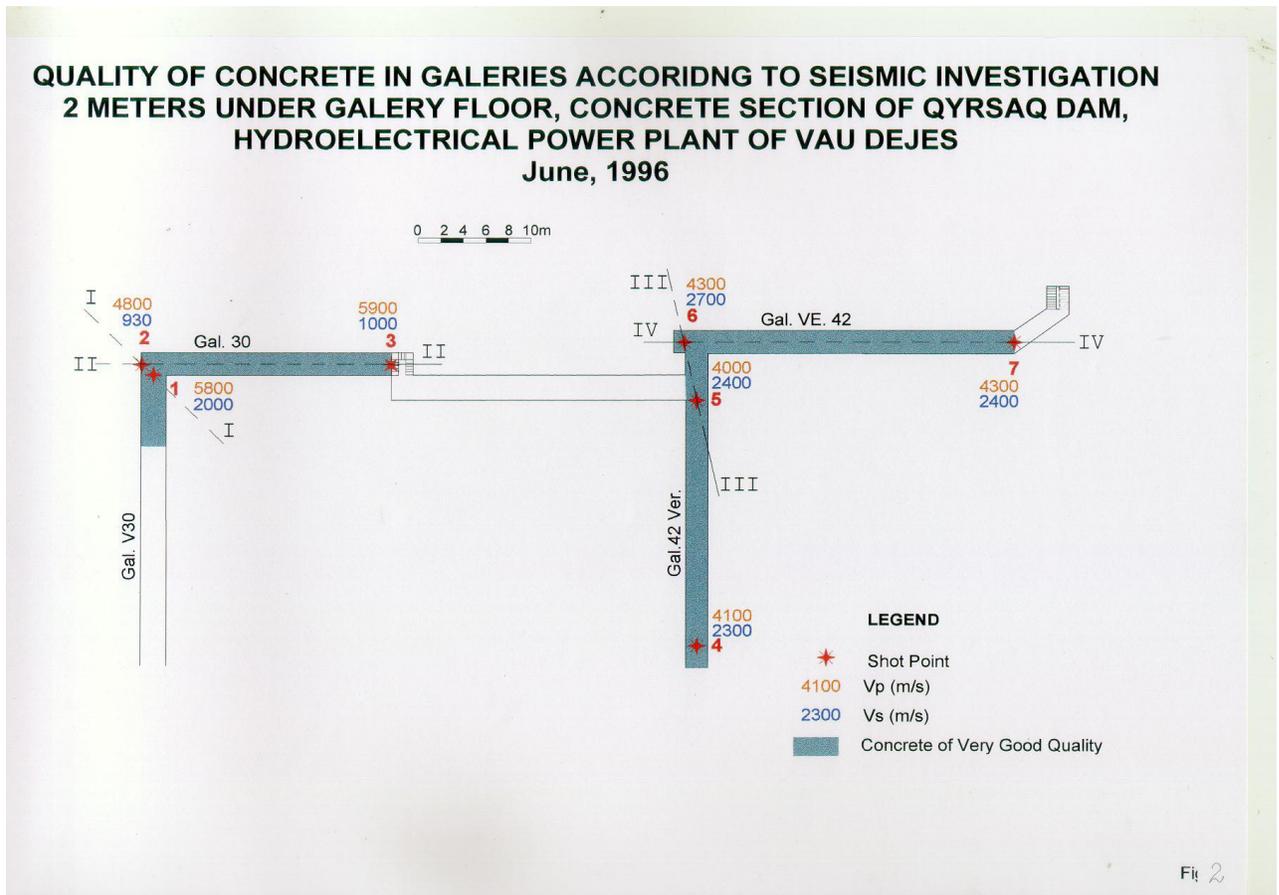
**QUALITY OF CONCRETE IN GALERIES ACCORDING TO SEISMIC INVESTIGATION
0.5 METERS UNDER GALERY FLOOR, CONCRETE SECTION OF QYRSAQ DAM,
HYDROELECTRICAL POWER PLANT OF VAU DEJES
June, 1996**

Tomography data at 30 m and 53.5 m in the concrete section of the Qyrsaqi dam showed that, generally, the concrete has a characteristic wave velocities of greater than $V_p=4000$ m/sec and $V_s=1900$ m/sec (Fig. 1). But, at the left dam edge, an area where the V_p decreases to less than 4000 m/sec exists. The fact that, together with the P-waves velocities, the S-waves velocity decreases, shows that in this sector, the concrete has weaker physical and mechanical properties.

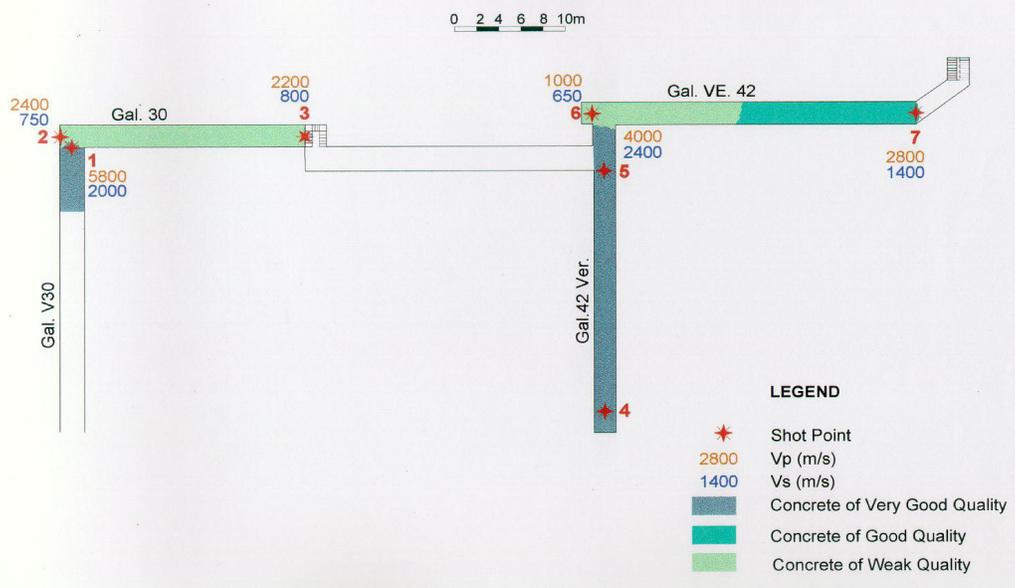
Fig.3

It is not enough to use only the seismic tomography among different galleries, because this leads to deficiencies in results and incorrectness in details. These results were compared with the supplementary seismic profiling on the concrete structure, especially in superficial spots. The concrete bottom of inspection galleries in Qyrsaqi dam also has good physical-mechanical properties. But in some sectors of the galleries, a superficial layer of some centimeters to 1 meter is attached, which mechanically is weak (Fig.2, 3, 4). The mechanically weak concrete layer shows that the concrete will deteriorate under the water's effect, or the cementing in these sectors was made by poor quality concrete. The surveys and tests we are going to develop further on will resolve this alternative.

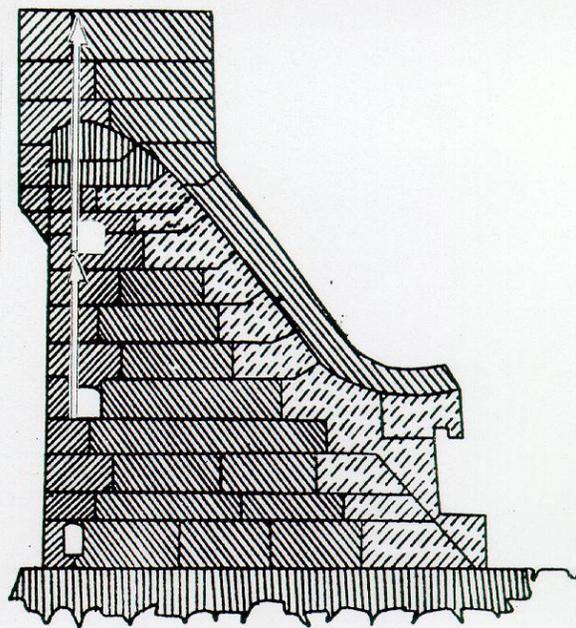
Fig.5

In the Ulza Dam (Fig. 5, 6), results from the seismic tomography survey indicates that the concrete in general is also characterized by high velocities of the seismic waves propagation $V_p= 4300-5035$ m/sec and $V_s= 2412-2429$ m/sec. The elasticity dynamic modulus is $(3.27-3.60)\times 10^5$ kG/cm². According to the tomography data, it is noticed that at the upper levels of dam, the longitudinal wave velocities V_p are, on average, higher than the lower levels. At the same time, at both levels, the transversal wave velocities are equal. In addition to that, the average square deviation of transversal wave velocity is almost twice less than the longitudinal wave deviation. These facts are an argument that the decrease in velocity and high fluctuations in velocities impacts on water penetration into the concrete pores. The velocities (V_p) in the lowest levels are lower than in the upper levels, as a result of being under constant high water pressure. The concrete of lower levels also contains more water. The mechanical properties of this concrete are also weaker than the upper levels. Considering the concrete mark 250 for lower levels (Dzievanski J. et al., 1981), based on the calculated

physical-mechanical properties, the upper levels have concrete of higher value than 250, because the elasticity dynamic modulus is $3.96 \times 10^5 \text{ kG/cm}^2$. In the tomogram it is possible to define a sector which characterized with physical-mechanical properties lower than the surrounding environment. Within this sector, the main water filtering of the gallery of lower level is observed.

Fig. 5. Cross-section of concrete blocks with different quality of Ulza Dam

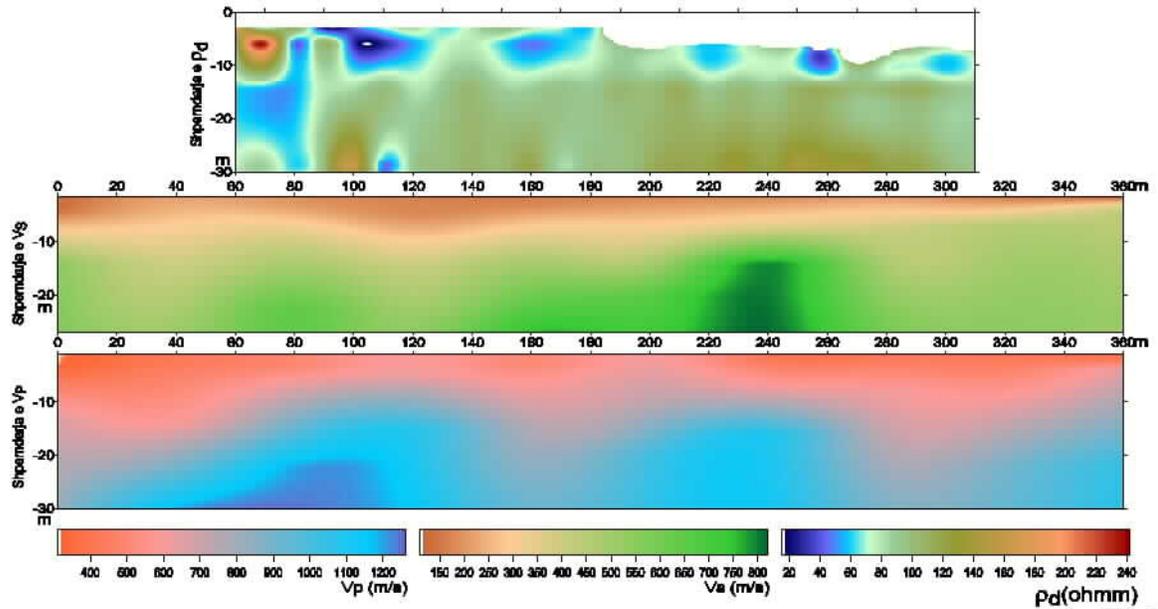
Fig.8

The clay material has a lower resistivity at the center and western edge of Qyrsaqi dam than the eastern edge (Fig. 8, 9). The seismic wave velocity is lower in this sector, too. The water filtering into the clay’s core explains this.

The seismic tomography section shows that, beneath the superficial layer at the top of the dam, which has a thickness of 2–10 m and low velocities of seismic waves, (respectively $V_p=1080 \text{ m/sec}$ and $V_s=550 \text{ m/sec}$), there is a second clay layer (Fig. 8). This layer of clay has a thickness of 4 – 21 m, increasing in thickness towards the west, where the ground dam meets the concrete part of the dam. The velocities of seismic waves are lower in western dam sector. The clay’s core, under the second layer, is characterized by higher seismic waves velocities (up to $V_p=2200 \text{ m/sec}$ and $V_s=800 \text{ m/sec}$). The elasticity dynamic module, calculated according to V_s data, varies from $(0.04-0.88) \cdot 10^5 \text{ kG/cm}^2$ for the second clay

core. Based on the geophysical investigation results, shown above, the areas with a lower electric resistivity and lower velocities of seismic waves than the other part of the dam's core, are interpreted to be due to water filtering through the clay core. This interpretation does not exclude the possibility of heterogeneity of the clay's material during dam's construction. The increase of velocities of the seismic waves toward depth shows that the clay's core is compacted. The configuration of seismic waves velocity contours in the section shows normal bedding of core's material, with western dip. The study of these dangerous phenomena brings the necessity of monitoring the dam through geophysical methods, along with all other installed equipment from the Geologic-Technical Service of Hydropower Plant. Some periodic investigation over many years are necessary in order to observe the changes in time of electric resistivity and the seismic waves velocities.
