**OUTLOOK ON MULTIDISCIPLINARY INTEGRATED GEOPHYSICAL-GEOLOGICAL  
STUDIES FOR SLOPE STABILITY INVESTIGATION AND LANDSLIDE MONITORING  
PRIOR TO ANY DEVELOPED AREAS IN ALBANIA**

*Alfred Frashëri<sup>1</sup>, Salvatore Bushati<sup>2</sup>*

*1- Faculty of geology and Mining, Polytechnic University of Tirana, Albania*

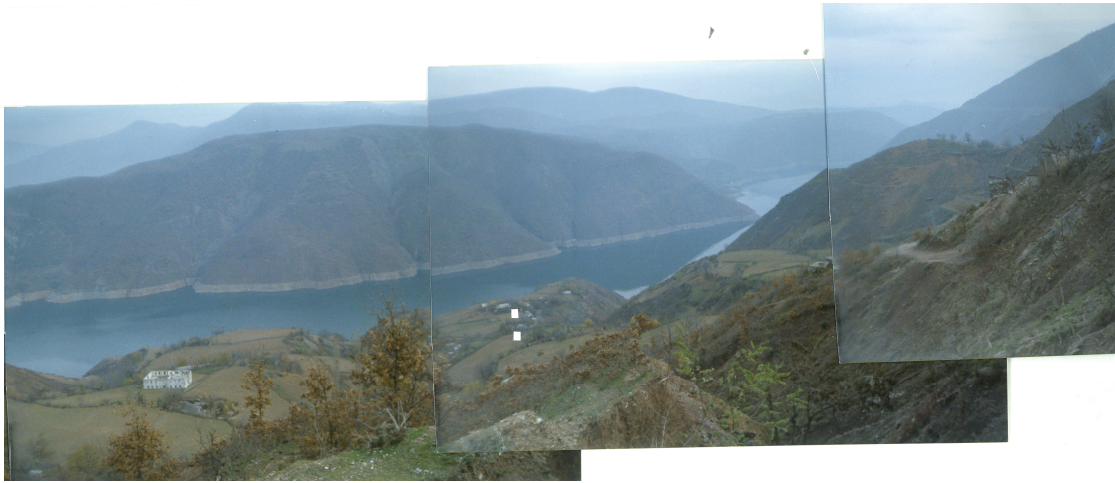
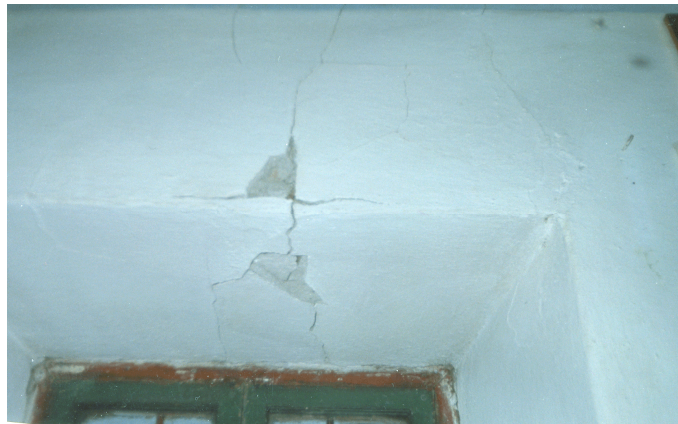
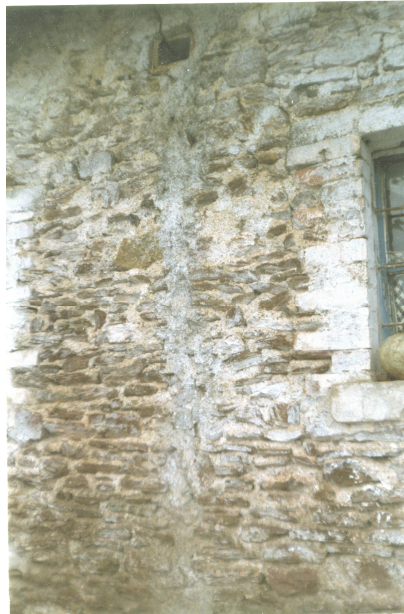
Cracks of the village houses walls

The most upper part of this slide's body, represented by the deluvial-eluvial deposits, is very active today and has very low specific electric resistivity values (120 - 500 Ohmm). Houses and other objects of the Porava district are constantly damaged by this activity.

By studying the natural seismic-acoustic activity, different recordings can be noticed in all the surveying zones. This shows that the sliding activity is different for different parts of the slipping body. The most dynamic zones of this sliding massif are located in places where the micro - movements have maximum intensity values. The Porava village is located in one of these zones. Because of this activity, many houses, and the soil is damaged and slopes have moved about 2 - 4 m within a 2 - 3 years period of time (1994 - 1996)(Photo 2, 3).

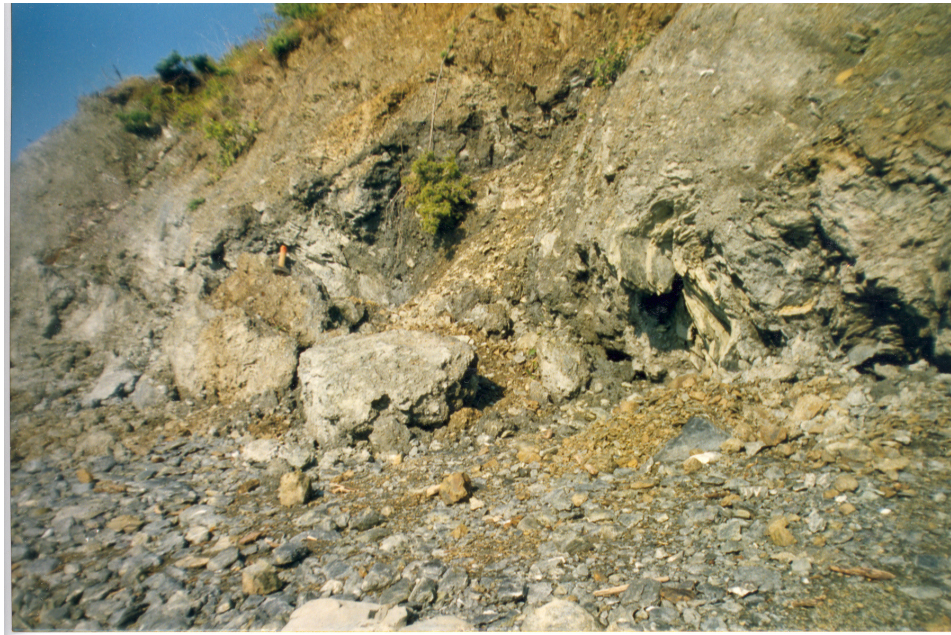
Ragami landslide body, mylonite serpentinites

The typical landslide was developed at lakeshore of the Vau Dejes Lake of Hydropower Plant in Northwestern Albania (Fig. 7). It is developed in the ophiolitic formation represented by serpentinized rocks. The slipping body represents a big mass of serpentinite, which is eolated, destroyed and covered by a thin layer of deluvium. According to the geological survey in 1992, the landslide did not exist. Landslide has been significantly developed during the last ten years (Fig. 8). The yearly movements of water level at Vau Dejes Lake caused a big landslide at eolated, weathered and destroyed serpentine rocks. Slipping body increased in the extent and in the volume substantially during this period. The front part of the slipping body is located along the shores of the lake. This part has the shape of a scarp about 2 -3 m high, and represents a destroyed, schistose serpentinite, partly in a form of mylonite (Photo 4, 5).

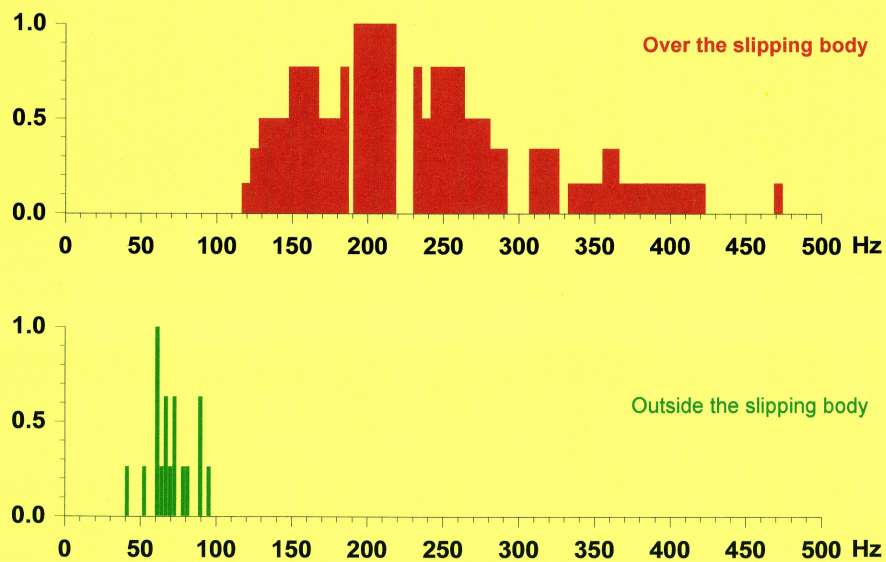
Fig. 15

## NORMALIZED SPECTRA OF SEISMOACOUSTICS ACTIVITY BANJA LANDSLIDE

This slide was characterized by a very intensive dynamic of the movement of the sliding body mass. For about one month, a sliding mass of 17 000 m<sup>3</sup> was displaced about 5 - 7 m, according to geodesic markers. This dynamic is also expressed in the natural sismoacoustic activity. Inside the sliding body predominate higher frequencies than outside it (Fig. 14). The micro - movements have an amplitude many times higher.

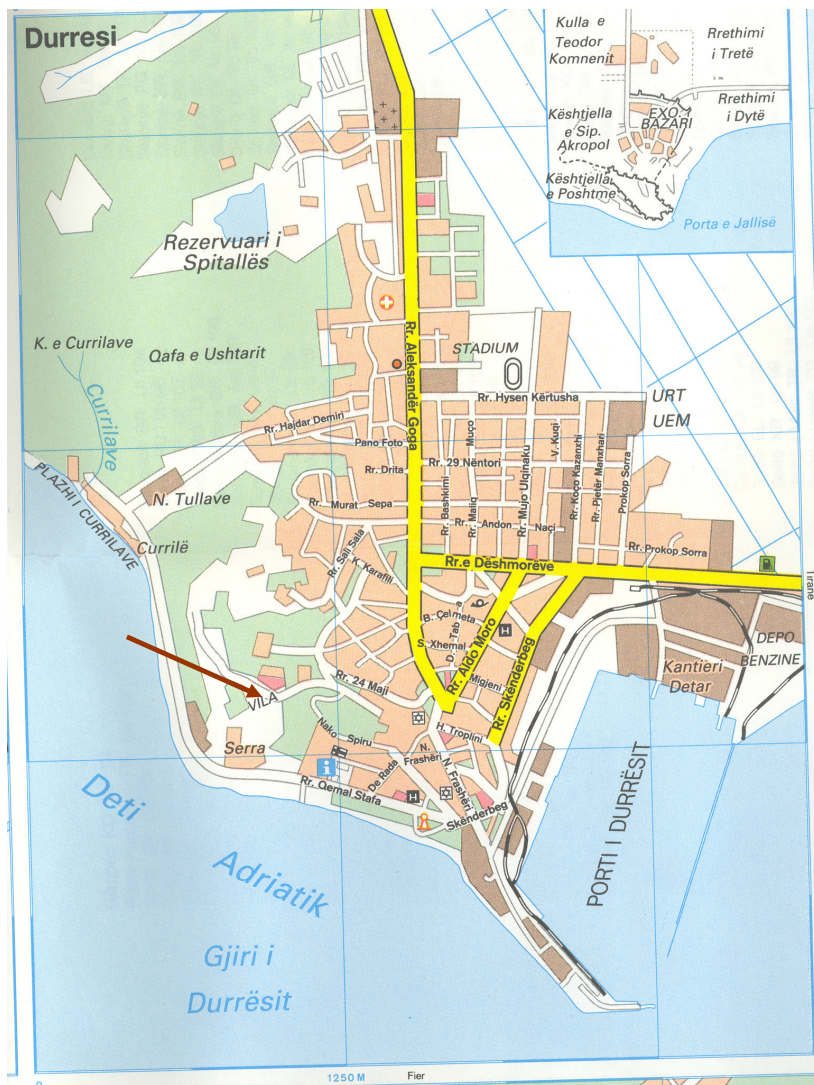
Durrësi City and landslide location

Durrësi city area is characterized by a presence of neogene molasses formation: (Frashëri A. 1987, Hyseni A., et al, 1976, 1986, Leci V. et al. 1986): sandstone-clay Tortonian deposits, clay, sandstone interbeds and lens, and gypsum debris and blocks Messinian deposits, and silty clay of. Pliocene Helmesi Suite ( $N_2^H$ ). Durrës structure is asymmetric top part of the big anticline. Western anticline limb has a dipping about  $20-30^\circ$ . Eastern flank is tectonically abrupt and has a dipping  $45-55^\circ$ . Top Durrësi anticline is located about 1600 m at the west of the coastal line. Part of Durrësi city is located over the Neogene's molasses hills (Photo 9). The Pliocene clay slope at southern part of the Durrësi hills is unstable. There the big landslide activity is observed (photo 10). Over this slope have been constructed many buildings. Actually, in several buildings have observed wide wall cracks.

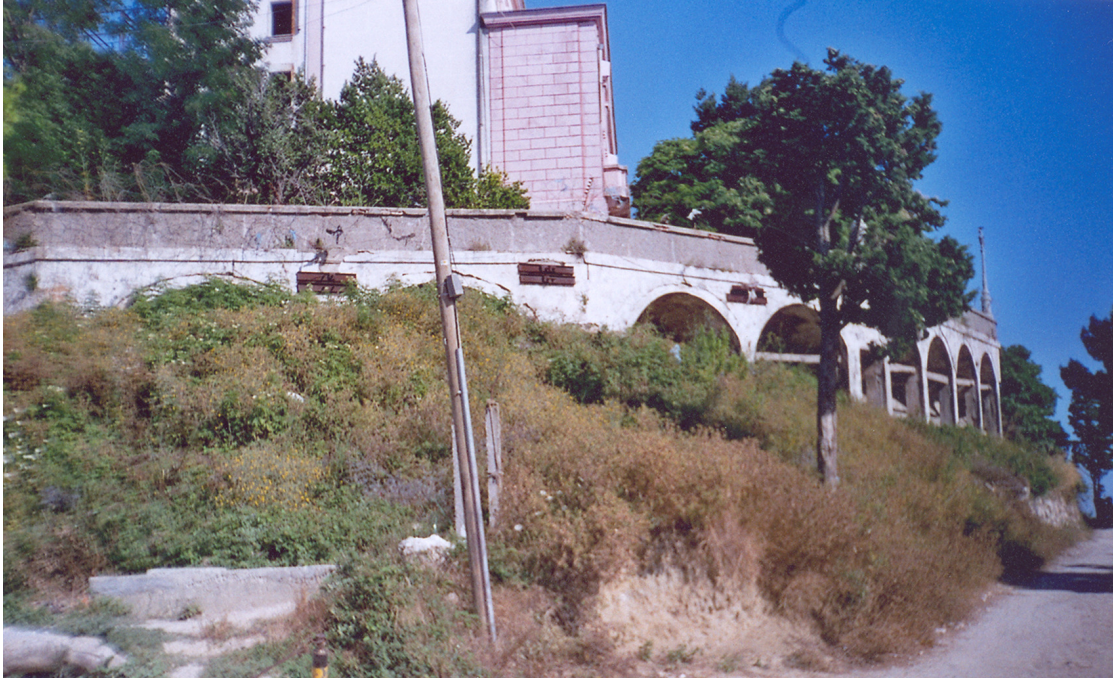
Subsidence of the villa wall, caused by landslide

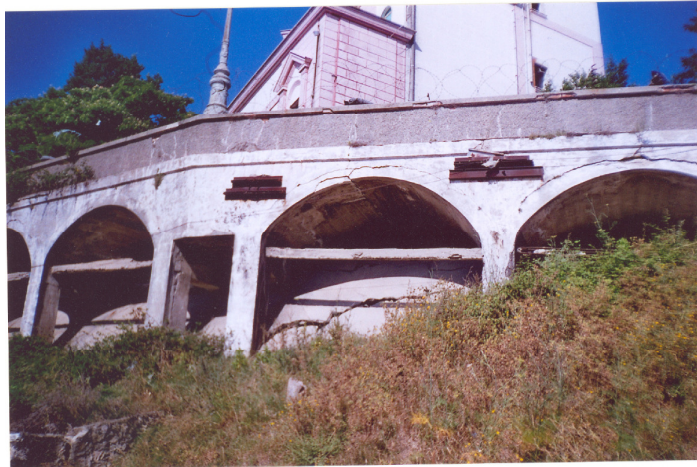
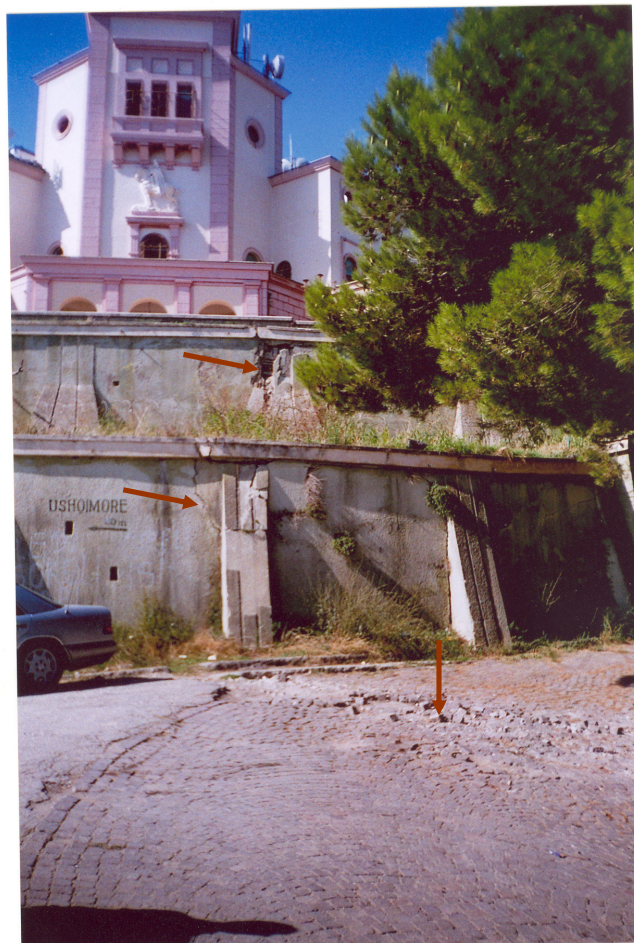
Cracks in the villa walls and transversaly of the road

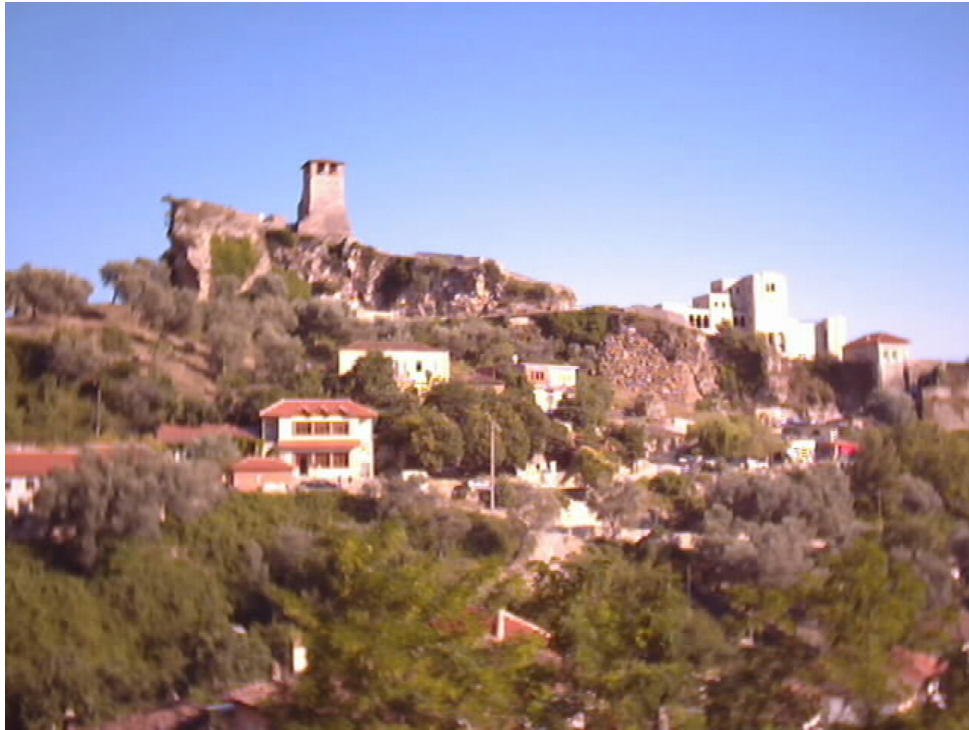
Kruja Castel

The Castle of Kruja is the symbol of the culture and Albanian history. This castle is related with the most glorious epoch of the Albanian National Hero Skanderbeg (Photo.11).

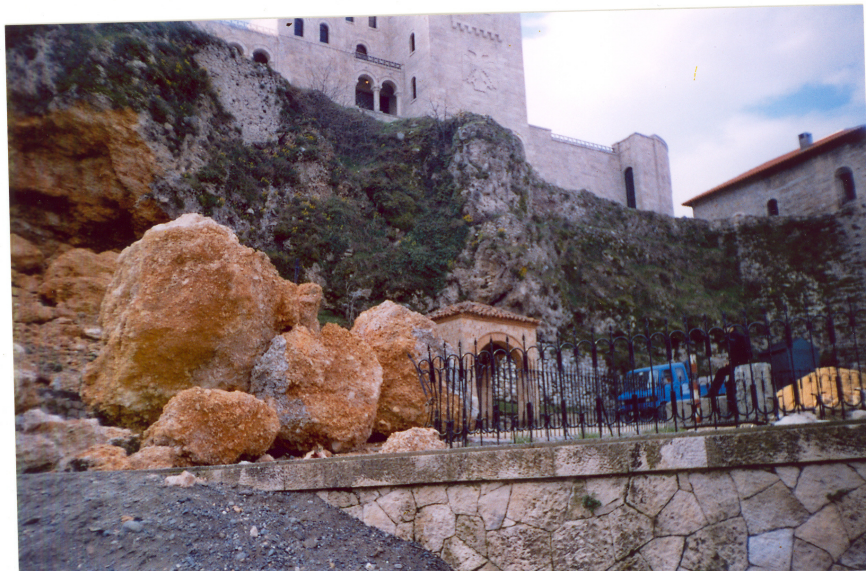
Downfalls in the Kruja hill

Many excavations have been conducted up to present, aiming at bringing out the interior part of the Castle and the clock tower. The surrounding walls have been completed with a museum structure as the Museum of the National Hero, where every visitor gets acquainted with one of the most remarkable moments of the Albanian history. In 1995, the Castle, which was considered relatively safe, was “shaken up” under the Gjergj Kastrioti Skenderbeg Museum. The downfall occurred after a period of heavy rainfall, characterized by heavy showers and a rapid decrease of temperature. The overnight downfall of the large detached masses of about hundreds of cubic meters was unexpected. Now the ground has started to deteriorate and at the sides of the castle, in some places is developing a process of collapse. This is a well known phenomena for this Castle. The deterioration has also continued during 1996-1997 though the detached rocks have been smaller in size.
