# European Geosciences Union General Assembly 2012, Vienna 22-27 April 2012

## A REVIEW ON ANTHROPOGENIC IMPACT TO THE MICRO PRESPA LAKE AND ITS DAMAGES

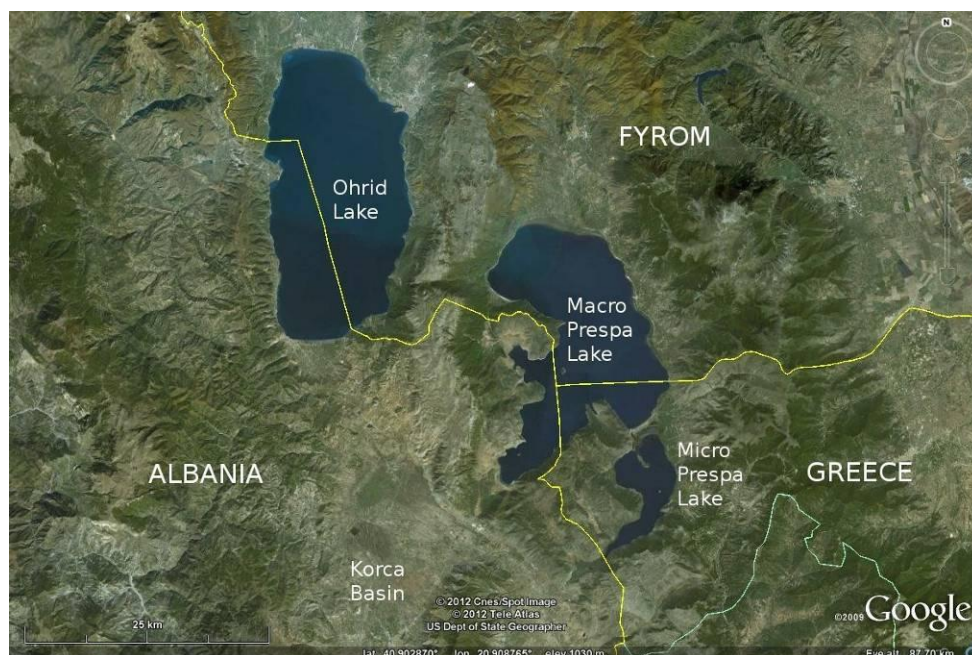
Fig. 1. Satellite image of Prespa-Ohrid lakes system.

The study area is located in the Western Balkans, and it is part of three Lakes System: Micro Prespa, Macro Prespa, and Ohrid. These lakes are located at the foot of the rocky Dry Mountain (Mali Thatë), which has a maximal altitude of 2287 m (Fig. 1).

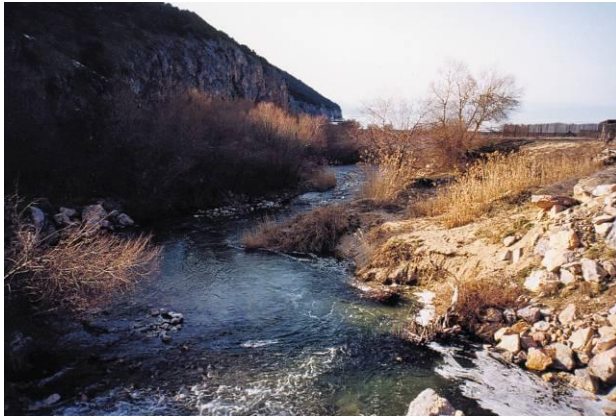
Photo 2. The discharge of Micro Prespa Lake water in to Macro Prespa Lake, through the channel in Greek side, 2000 y.

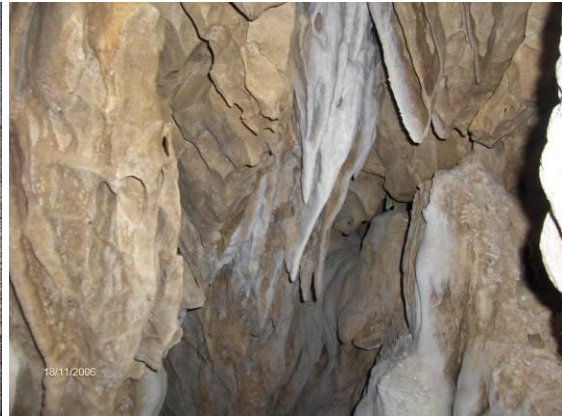
Photo 3. Karstic activity, Macro Prespa Lake, 2006 y.

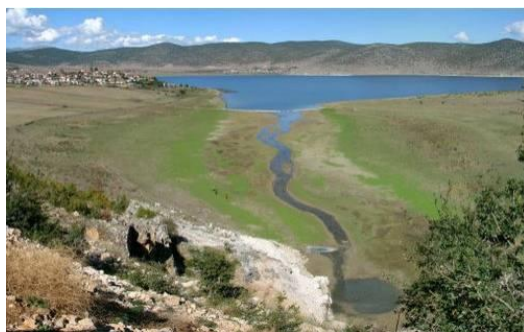
Photo 4. Point of the disappearing Macro Prespa water, which migrated to Ohrid Lake (from Google Earth).

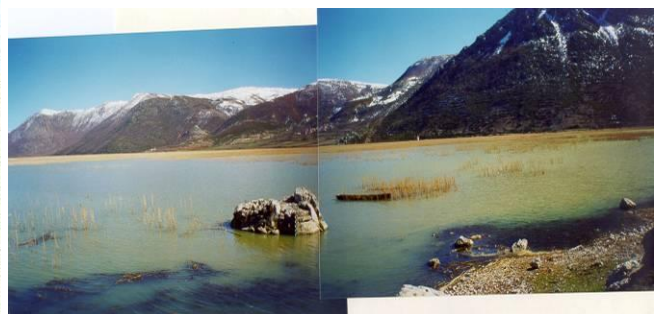
Photo 5. Troubles waters in Micro Prespa Lake, 2000 y.

Macro Prespa water is very clear up to 20 m depth and it is light blue. During the summer the water temperature is up to 24oC and during the winter it goes up to 0.4oC. Some torrent flows in the eastern part of Macro Prespa and there have not any surface emissary. Intensive water discharges through subterranean ways mainly in Ohrid Lake, that is 145 m lower and in some karstic springs is Devolli plain. Macro Prespa water discharge into karstic limestone of Dry Mountain is very obvious near Gollomboç village (Photo 3, 4). Micro Prespa water was very clear too. Stones in its lake floor looked like beautiful mosaic. At the end of 20 century, water is completely turbid (Photo 5).

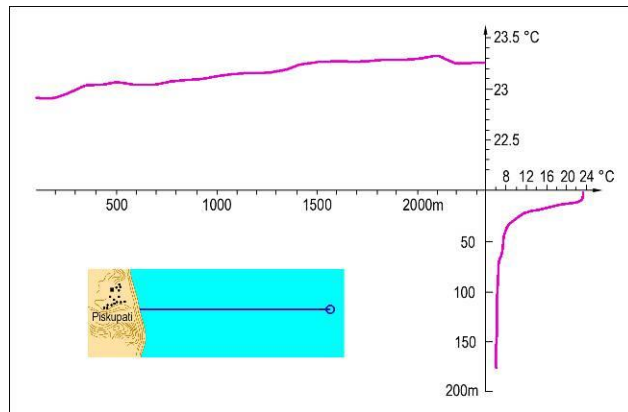
Fig. 4. Water temperature of Ohrid lake.

Ohrid is a two national lake lying in the territories of FYROM (70 %) and Albania (30%). It is a tectonic lake, formed during the Upper Miocene. It belongs to the oldest lakes group in the world, having the epithet “ Natural Monument of Europe”. UNESCO has registered the Ohrid Lake as “Natural and Cultural Inheritance of the World” since 1979. Its water level is 695 m and the average depth 145 m. The maximal depth is 295 m, making it one of the deepest lakes in the Europe. Water temperature profil is presented in Fig. 4.

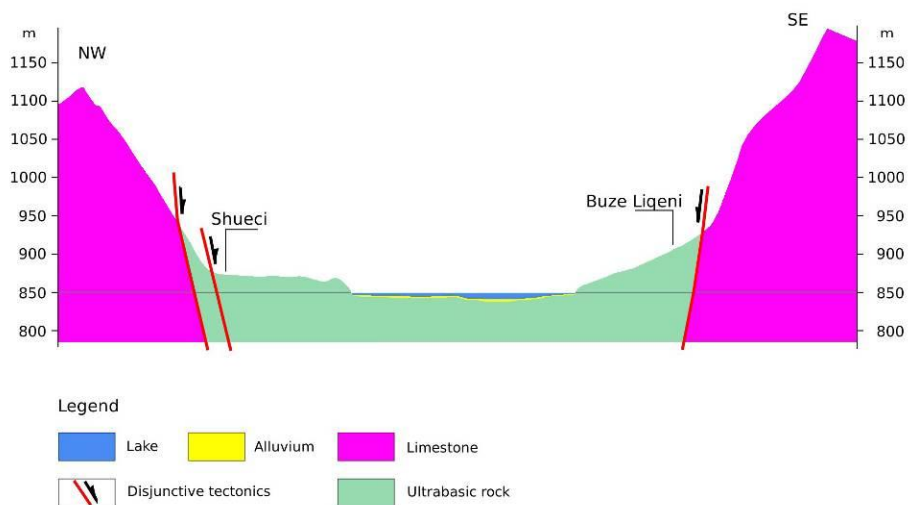
Fig. 6. Geological Profile through Micro Prespa Lake

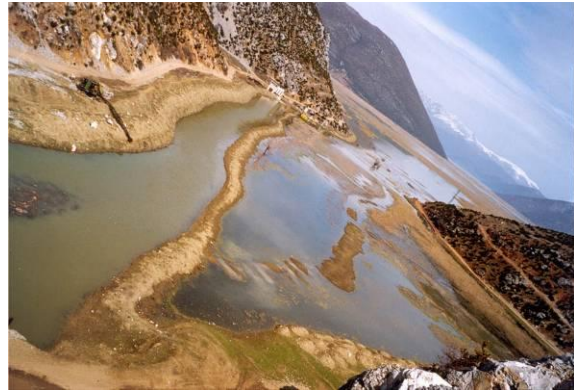
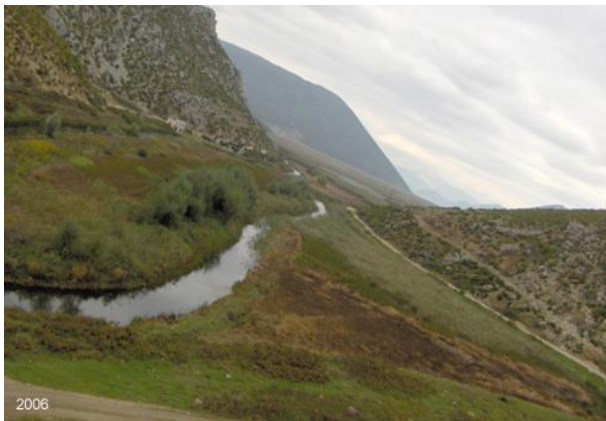
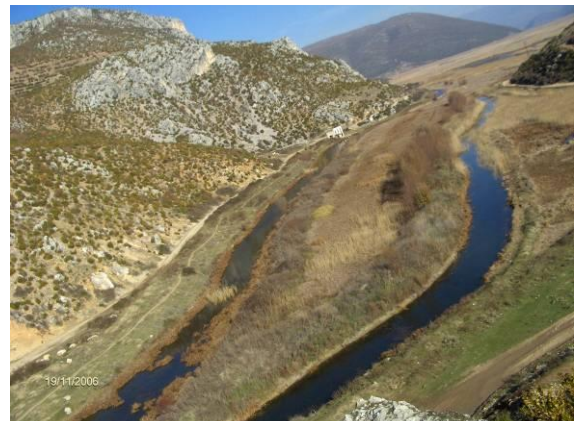
Photo 10. General view of the damages of ecosystem at Prespa Lake shore,  
(a) 2000 y., (b)(c) 2006 y.

According to the American Classification ASTM, this sediment is classified as Lean Clay CL. According to their plasticity index  $I_p=13.5$ , and to the upper and lower limit of the plasticity, respectively  $W_l= 42.2\%$  and  $W_p=28.7 \%$ , illite and montmorillonite represents this clay material. Great amount of Devolli River waters flowing in to Micro Prespa Lake during the winter. A considerable amount of solid matter enter in to the Prespa Lake and were decanted in the lake. Under existing conditions, Micro Prespa Lake plays the role of an authentic gigantic decanter (Photo 10a, b, c).

Photo 10 (a, b, c). General view of the damages of ecosystem at Prespa Lakeshores, 2000 y. (a, b), (2006) (c)

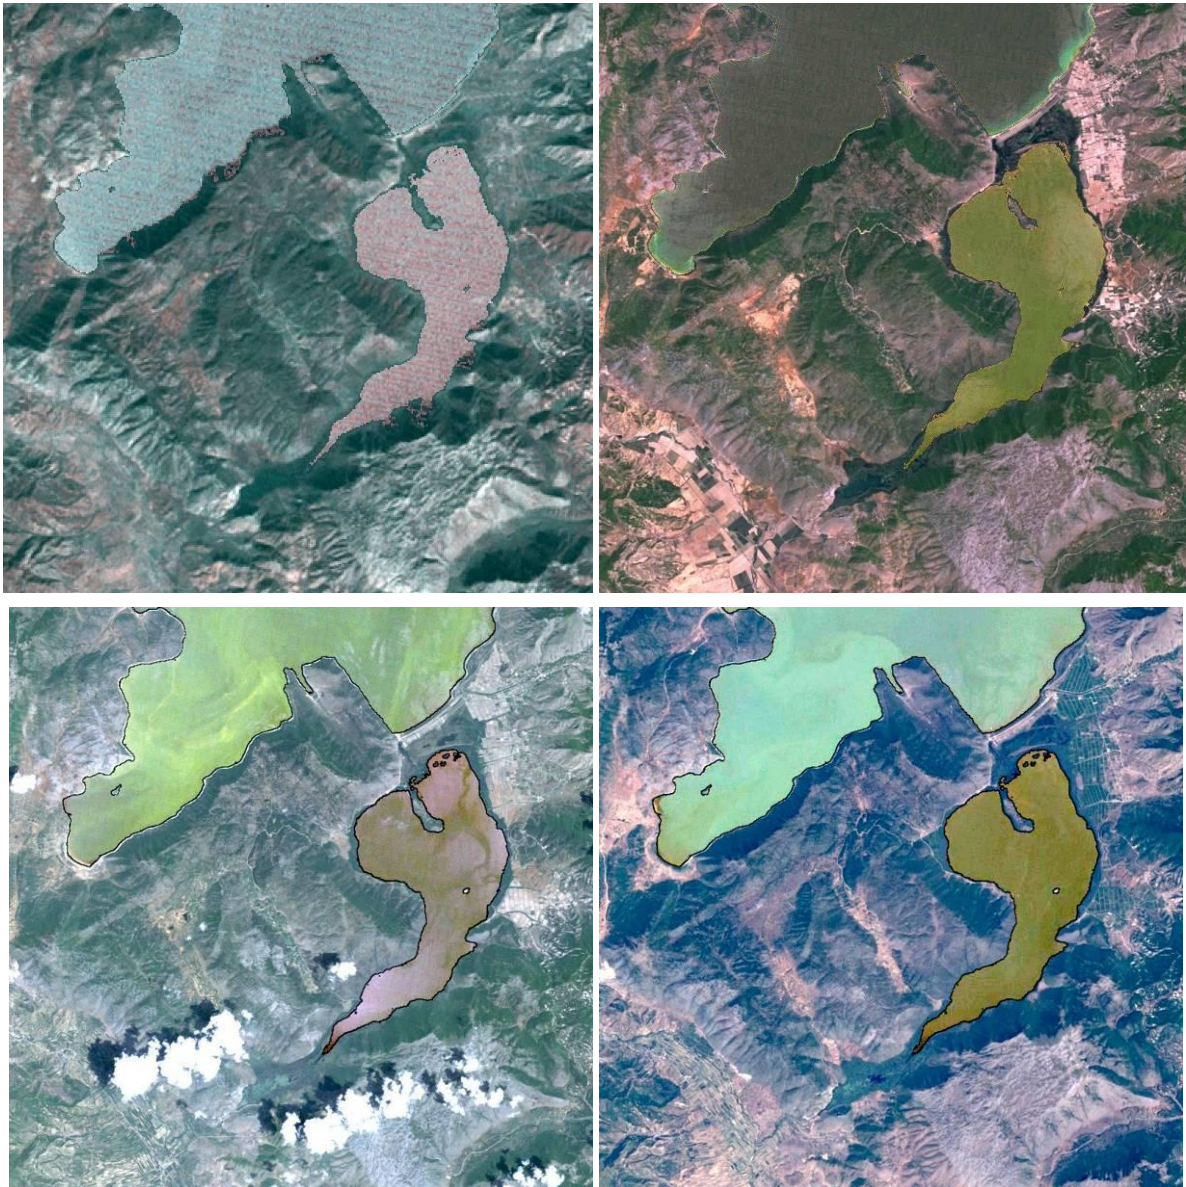
Fig. Aaa – Natural enhanced colors of Macro and Micro Prespa Lakes (top left ~ 1972, top right ~ 1987, bottom left ~ 2002, bottom right ~ 2010)

In 1972 there are no significant turbulences in both Macro Prespa and Micro Prespa. Water of Micro Prespa looked more “reddish” probably because of being more shallow. Instead, in 1987 there are first signs of turbulences in Micro Prespa, and first signs of turbulences near shores in Macro Prespa. Situation resulted dramatic in 2002, while showed a little improvement in 2010 as result of interruption of water flow from River Devolli in Southwestern corner of Micro Prespa (colors of this corner are not enhanced).

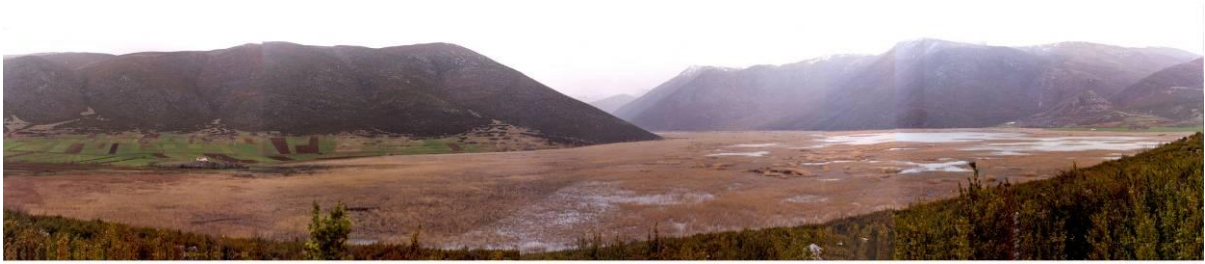
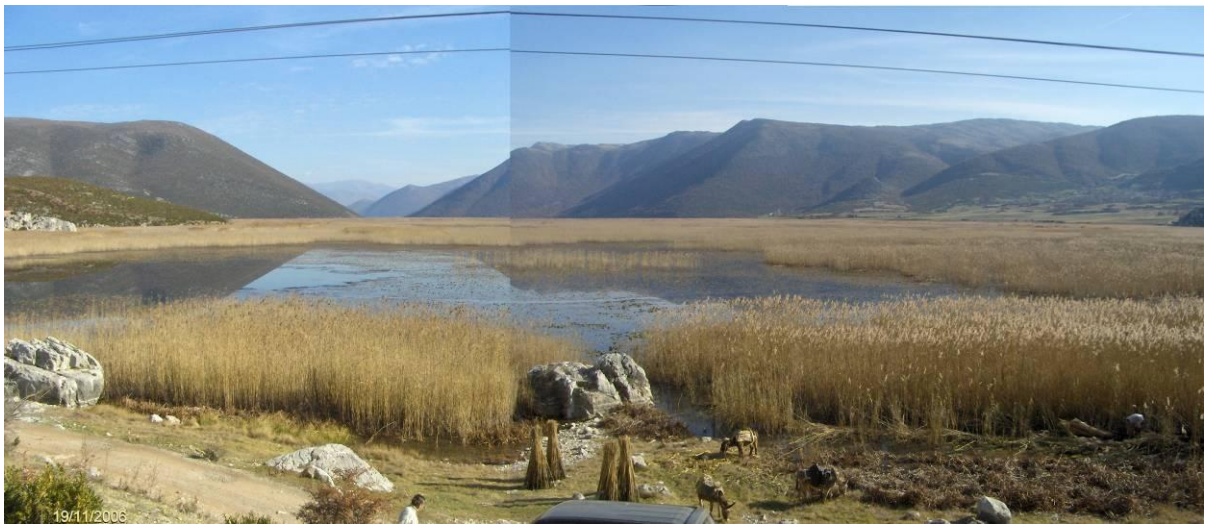
Photo 11. Eutrophication of the Micro Prespa Lake water, 2000 y.

Micro Prespa Lake has great problems of eutrophism (Photo 1c, 11, 12). Eutrophication processes are promoted by enrichment in nutrients. The direct consequence of such addition is represented by a change in biodiversity (Bega F. 2000, Bimo T. 2000, Pano, N. et al 1997, Pano, N. and Frashëri, A 2000, Pepo E. 2000, Qoshja, Zh. 1979, Rakaj N. 2000, Shumka S. 2000).

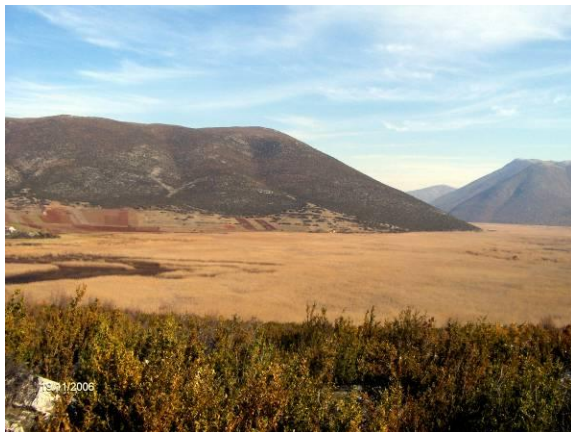
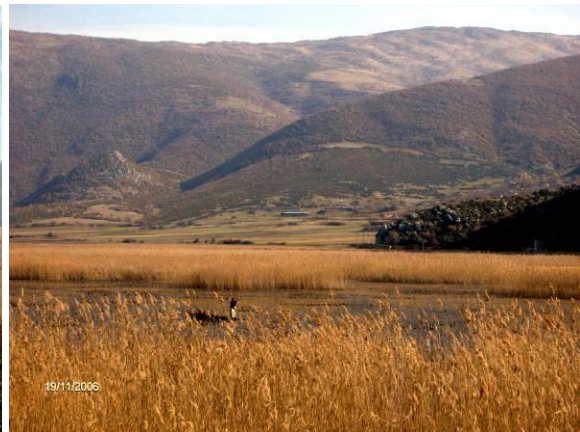
Photo 12a, b. Eutrophication of the Micro Prespa Lake water, 2006 y.
