**20<sup>th</sup> European Meeting of Environmental and  
Engineering Geophysics**

**IMPACT OF HYDROPOWER PLANT  
WATERS ON THE DESTABILIZATION  
OF SHORES AND CAUSING  
LANDSLIDE TO ITS SHORES**

*Alfred FRASHERI*

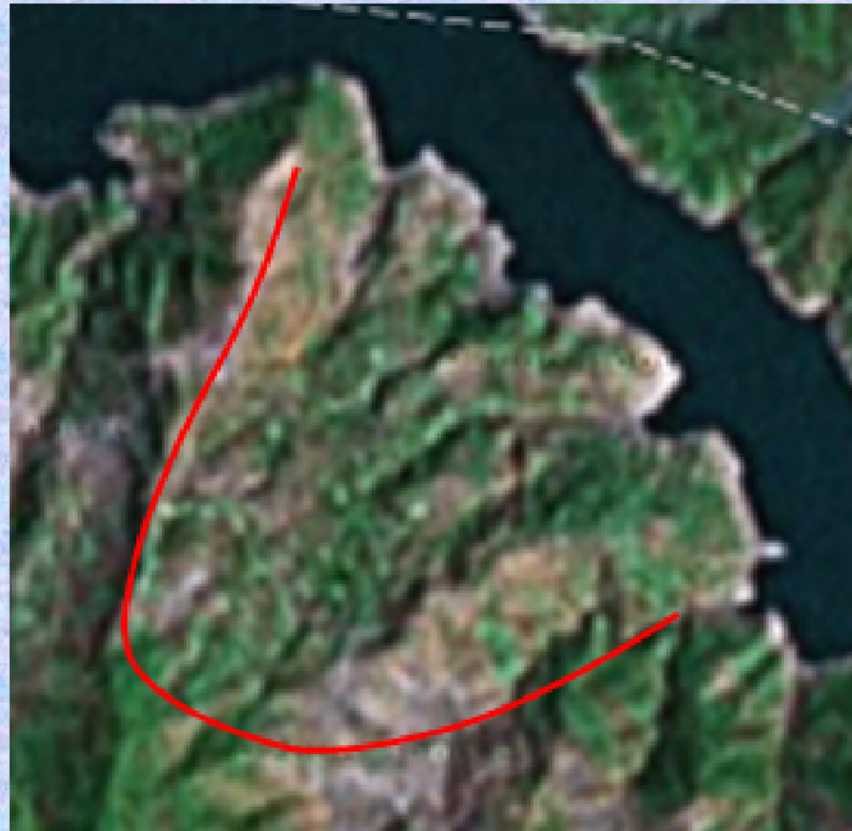
PORAVA  
LANDSLIDE

There are observed active **landslides** in the lakeshores. The most biggest is landslide at Porava village, about 2,5 km from the Fierza dam, and Ragami landslide near of Ragami Dam in Vau Dejës. **These landslises represent a great geological risk for hydropower plants, and Porava village. Walls of the houses are broken in Porava villages.**

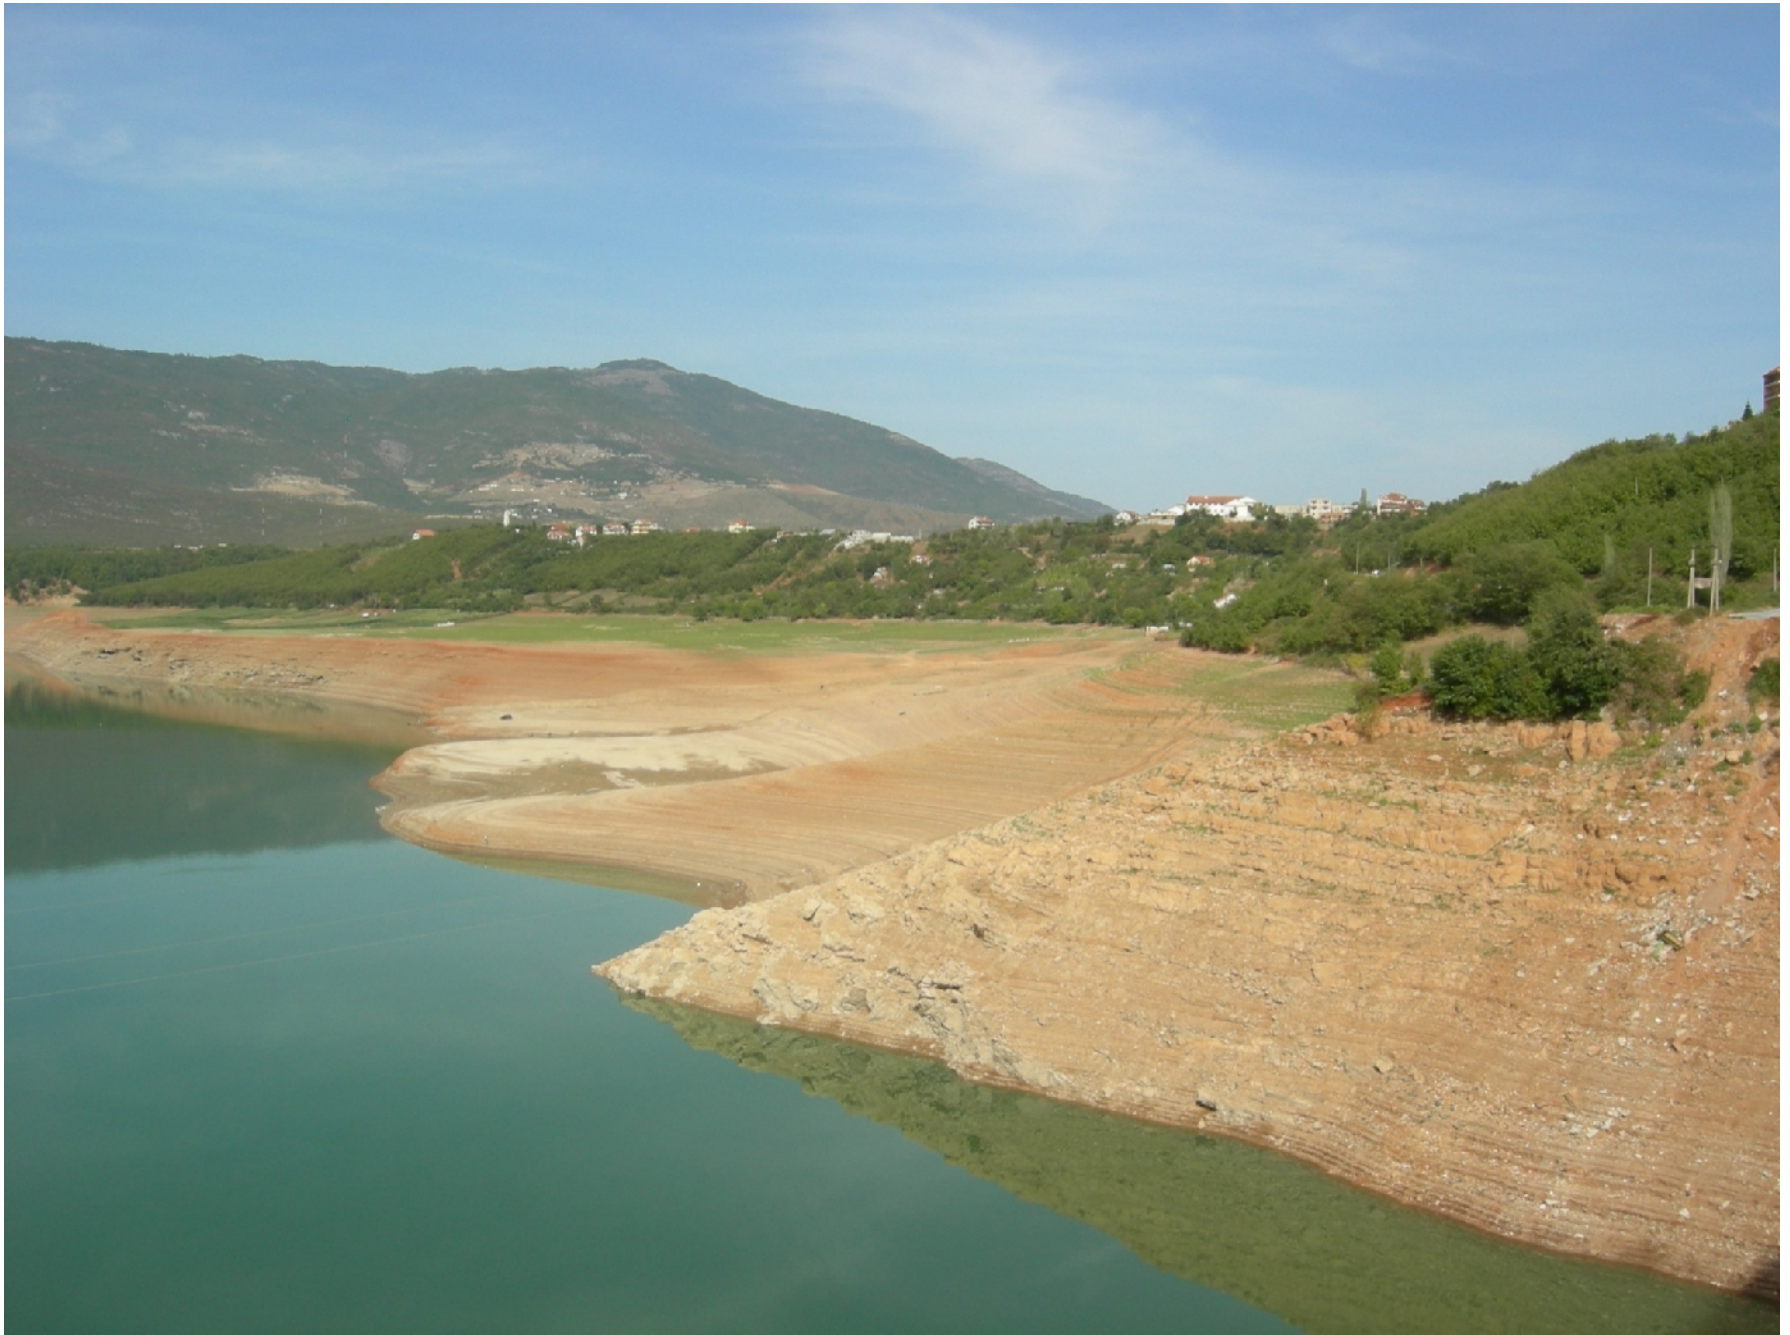
# LOW FIERZA WATER LEVEL, SEPTEMBER 2013

- **Difference between maximal and minimal levels of surface water in lake was varied over the years from some meters up to 30 or more meters, depending on the annual meteorological conditions.**

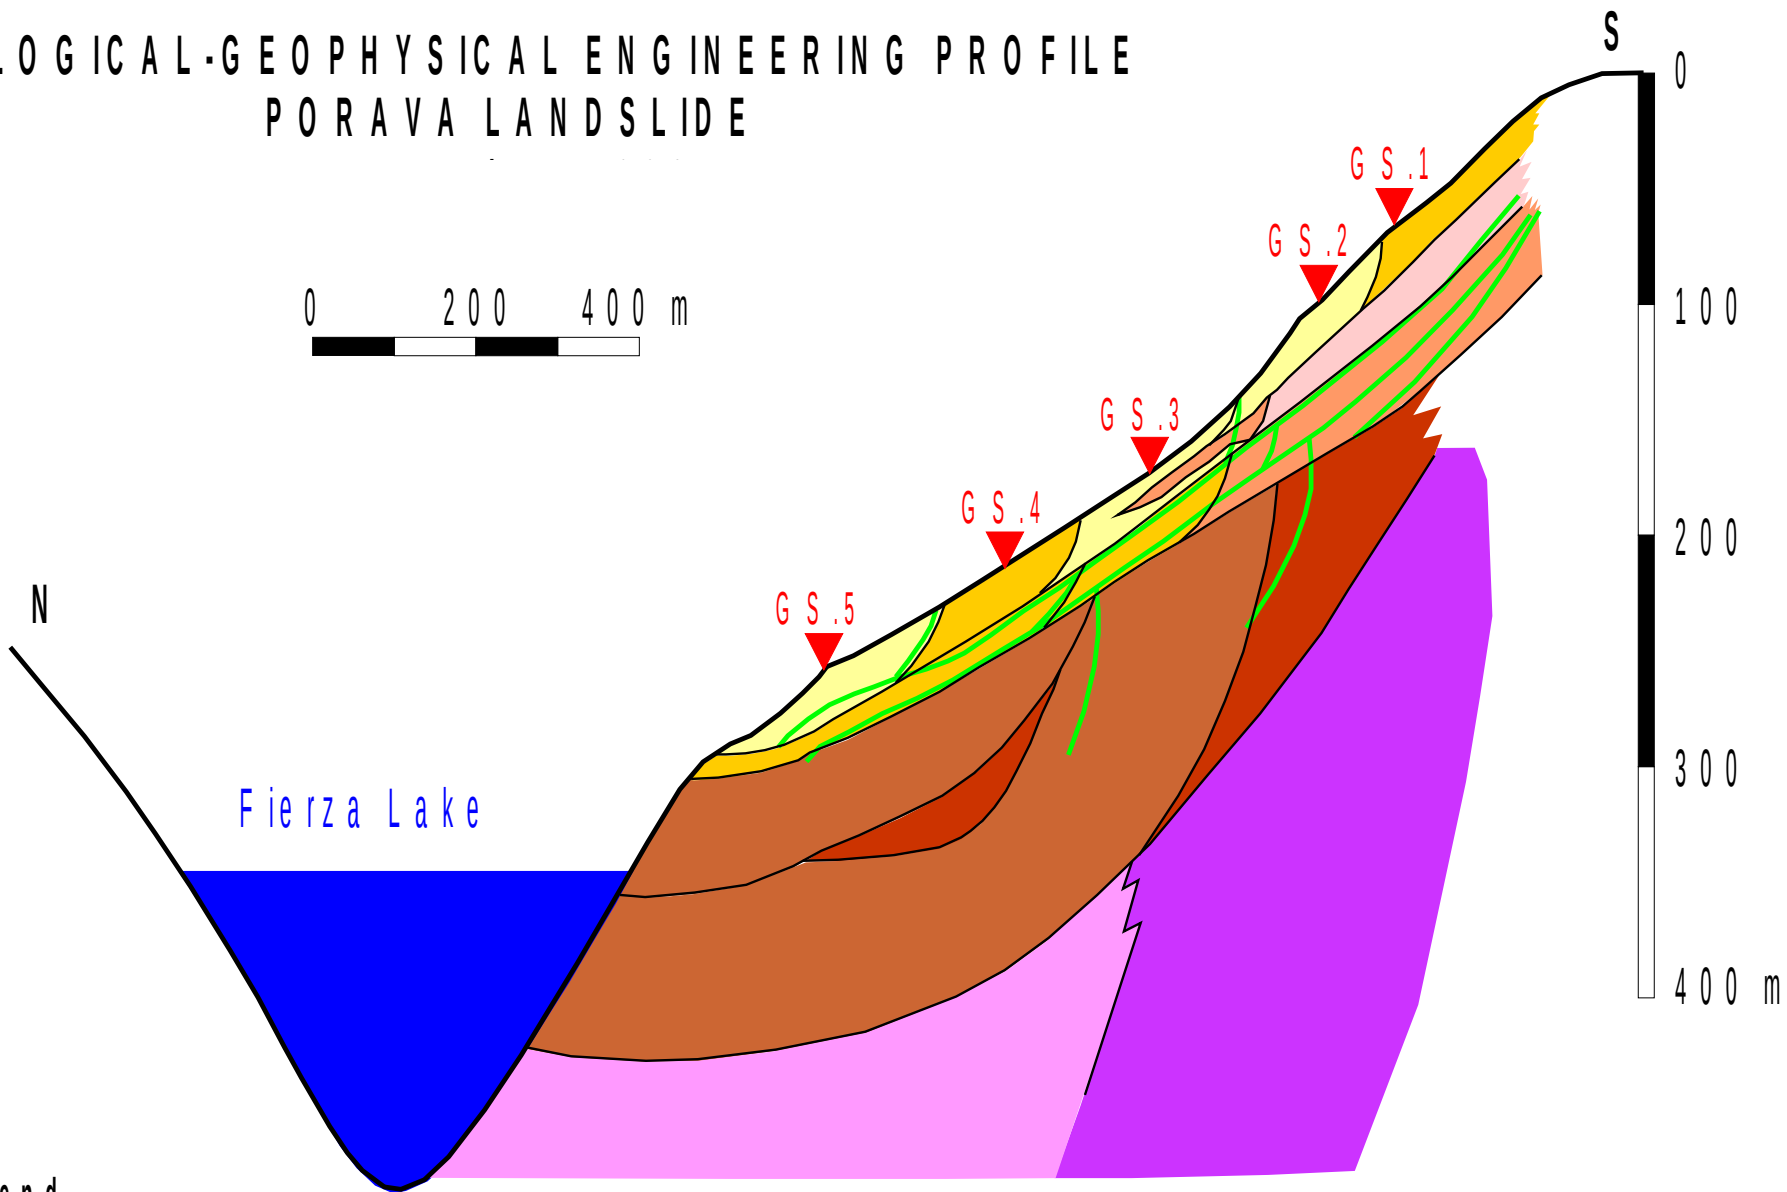
# GEOLOGICAL-GEOPHYSICAL ENGINEERING PROFILE PORAVA LANDSLIDE

| Goelectrical boundary | Deluvium, most active part of slipping body | Volcanogenic-sedimentary bedrock, resistivity. 1000-1500 Ohm m |
| Seismic sizm ik | Volcanogenic-sedimentary slipping block, resistivity. 250-350 Ohm m, $V_p=1400-3800$ m/s | Volcanogenic-sedimentary bedrock, resistivity. 3000-3500 Ohm m |
| Geophysical survey centre | Volcanogenic-sedimentary slipping block, resistivity. 500-300 Ohm m, $V_p=3000-3800$ m/s | |

In the integrated geophysical-geological profiles are fixed studied landslides bodies. In these profiles were also clearly fixed the sliding plains.

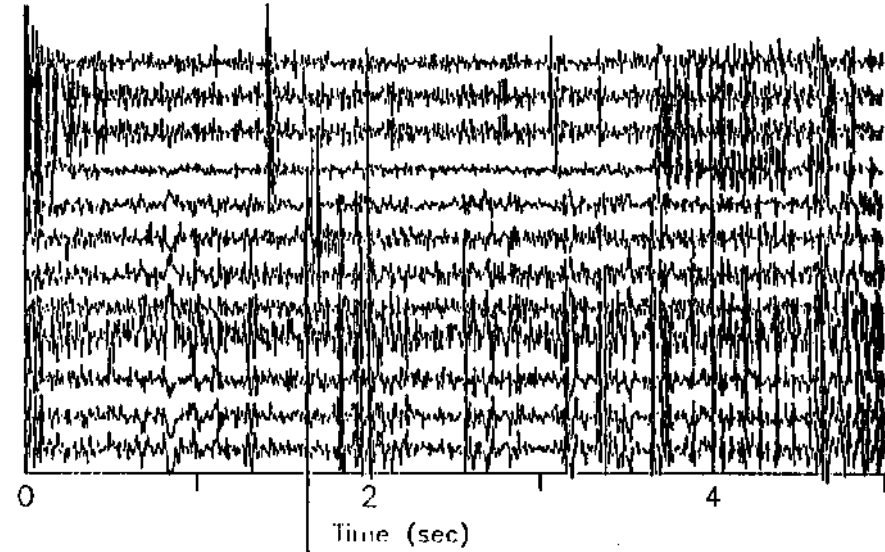
Outside of slipping body

Inside of slipping body

**Natural seismic-acoustic activity  
in the Ragami landslide area**
